OBD2K2

LESSONS LEARNED

TOM MOYE

VT OBDII CASE STUDY

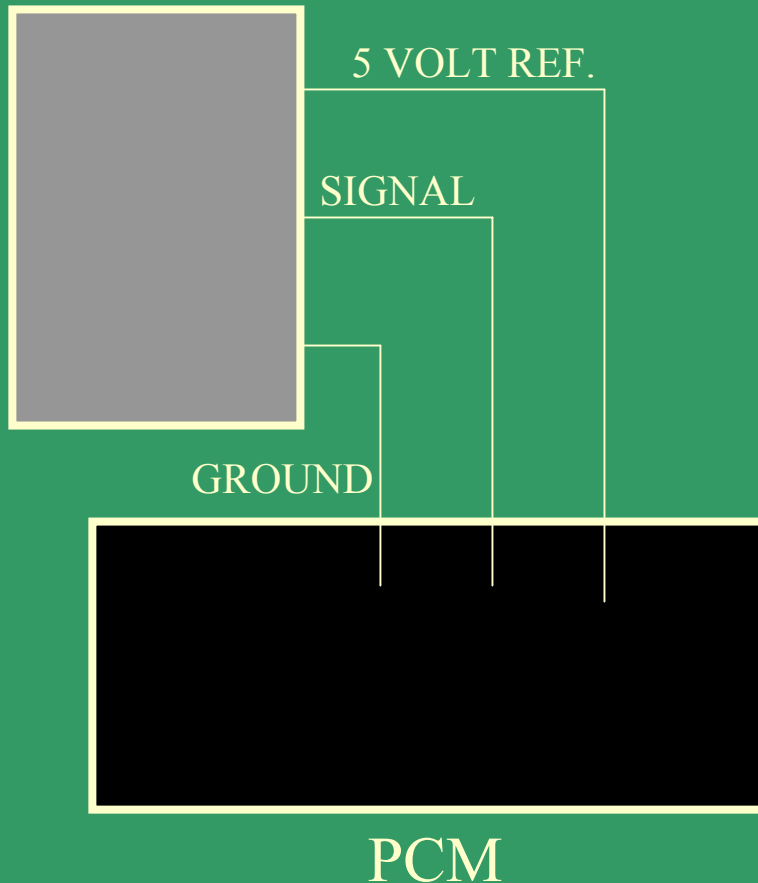
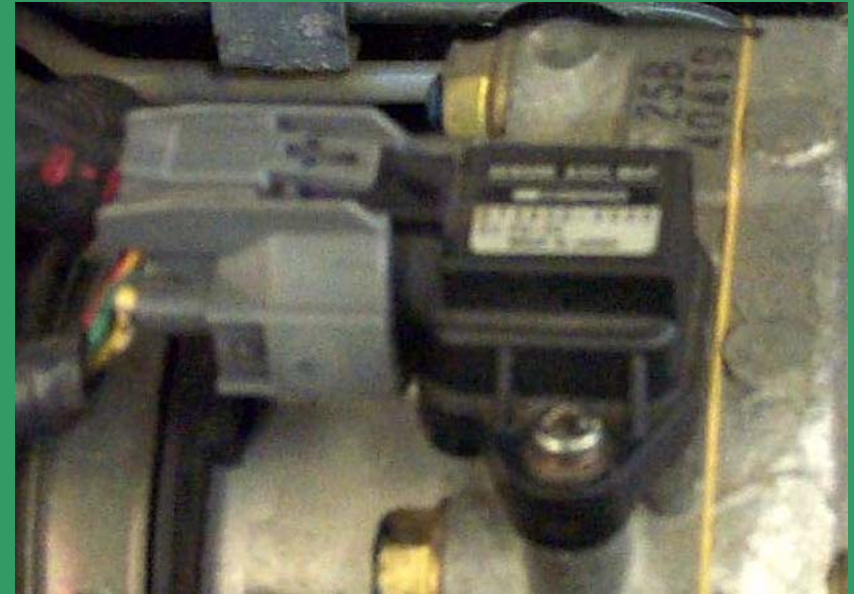
MAP Sensor

- P0105 MAP CIRCUIT PROBLEM
- P0106 MAP RANGE OR PERF.
- P0107 MAP LOW INPUT
- P0108 MAP HIGH INPUT
- P0109 MAP INTERMITTENT

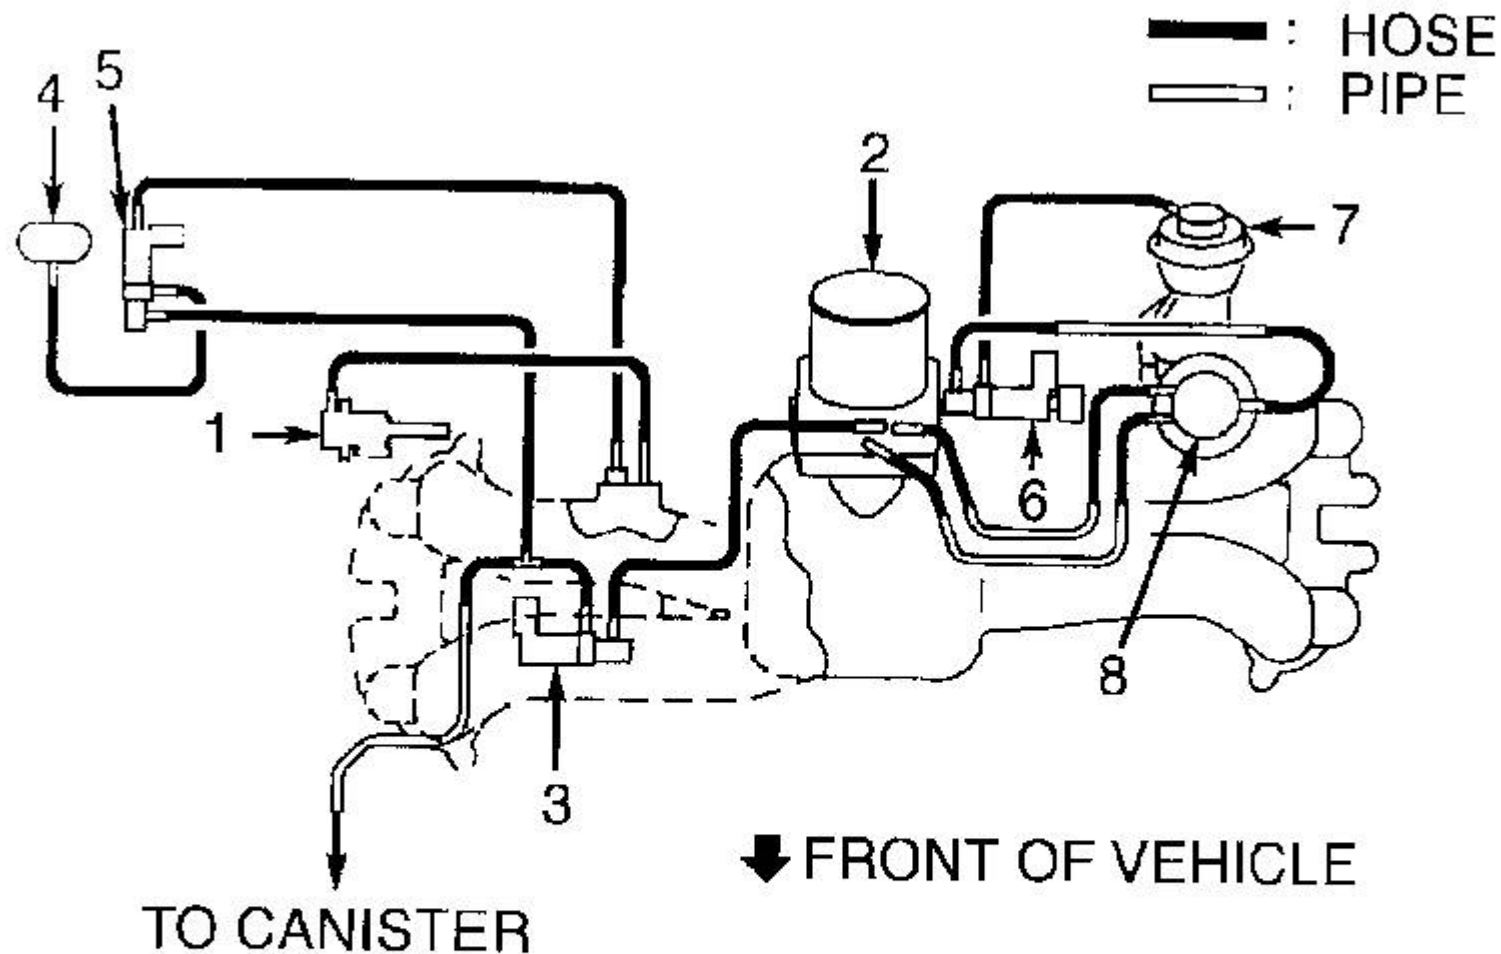
- Tested MAP sensor with scan tool
 - MAP pressure signal: ~ 28” HG pressure w/ KOEO and KOER, indicating problem
- Tested vacuum supply to MAP sensor
 - No vacuum found at supply line at idle
 - Found vacuum supply line connected to unknown component (not a vacuum source)
- Referenced vacuum routing diagram
 - Corrected vacuum line routing

- Thorough visual check is necessary
 - ~75% of problems can be identified visually
 - Checking vacuum routing diagram would have identified problem immediately
- Need to confirm repair
 - Previous repair was incomplete
 - MAP sensor replacement was appropriate, but vacuum hoses not correctly reconnected

- Re-tested MAP Sensor
 - Checked 5 volt reference and ground: OK
 - Checked signal voltage vs. vacuum: OK
 - Checked MAP sensor reading on scan tool: OK
- Cleared codes, test drove several trips
 - MIL OFF
