Field campaign

Topic	Engine control module update - Mulsanne (SC 23/12)
Market area	China 796 VW Import Comp. Ltd (Vico), Beijing (6796),Korea, (South) E08 Bentley South Korea (6E08),United States E05 Bentley USA and rest America (6E05)
Brand	Bentley
Transaction No.	2070237/1
Campaign number	EC77
Note	
Type	
US code

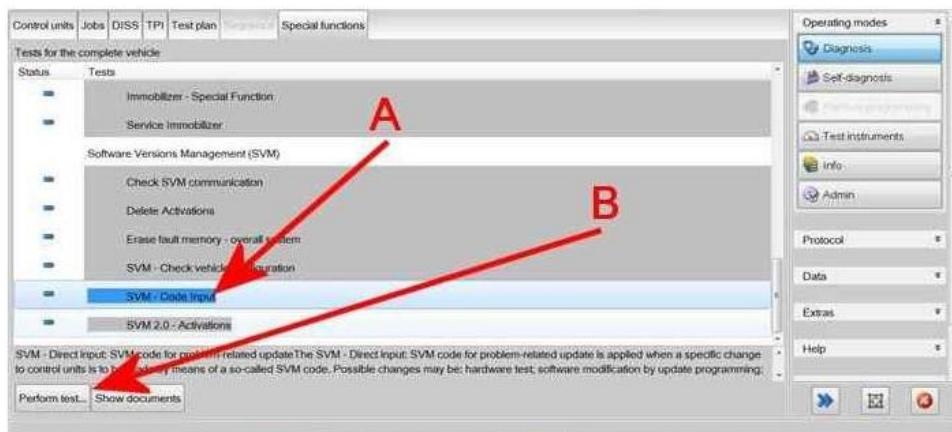
Figure 1

- Within the Special functions tab select SVM - Code input then select Perform test (Figure 1)

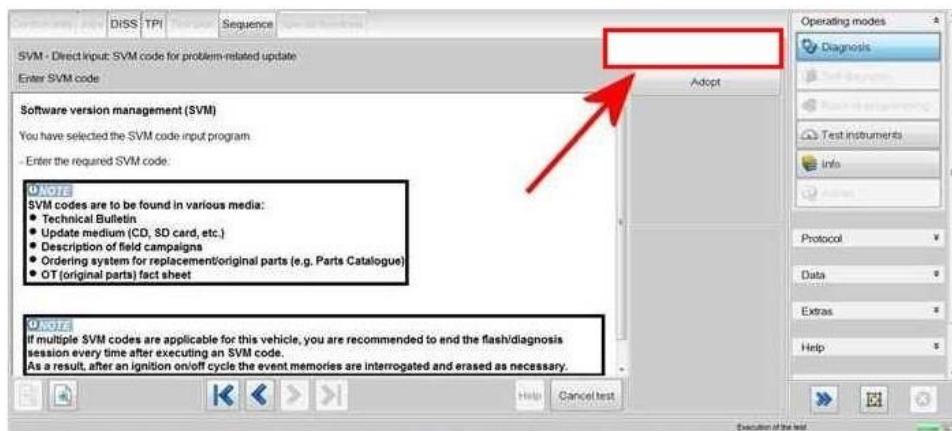
Figure 2

2) On the next screen enter SVM code **3Y0ECMLEVC601** (Figure 2)

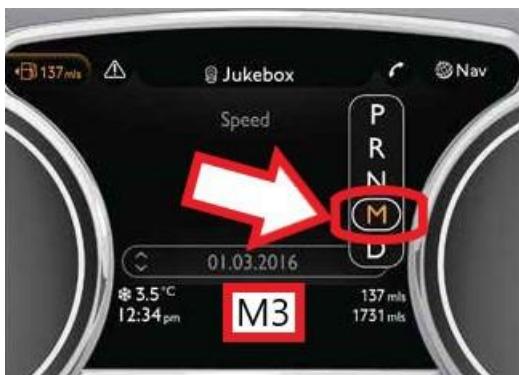
Figure 3

Confirm M drive is selected by viewing the gear selection status in the Drivers Information Panel (Figure 3)

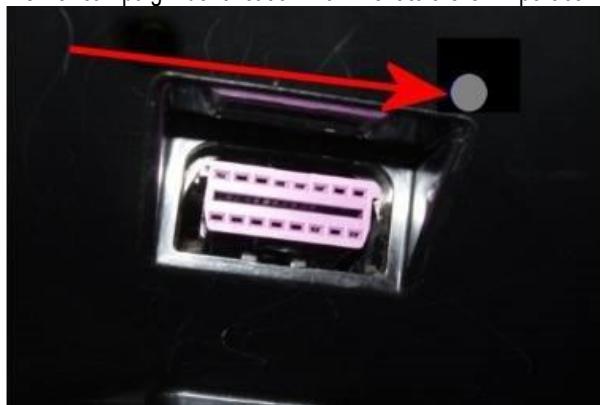
Figure 4

A silver campaign identification mark next to the OBD port confirms completion (Figure 4)

9) Apply a silver paint completion mark as shown in the Identification section (Figure 4)
